THE GALLOPING GRAIN GRINDER

A large segment of a welded blower fan assembly on an operating grain and feed mill flew off and killed the owner. This case follows the investigation into why the blower failed.

© 1982 by the American Society for Engineering Education.
Written by C. O. Smith, College of Engineering and
Technology, University of Nebraska, Omaha, Nebraska.

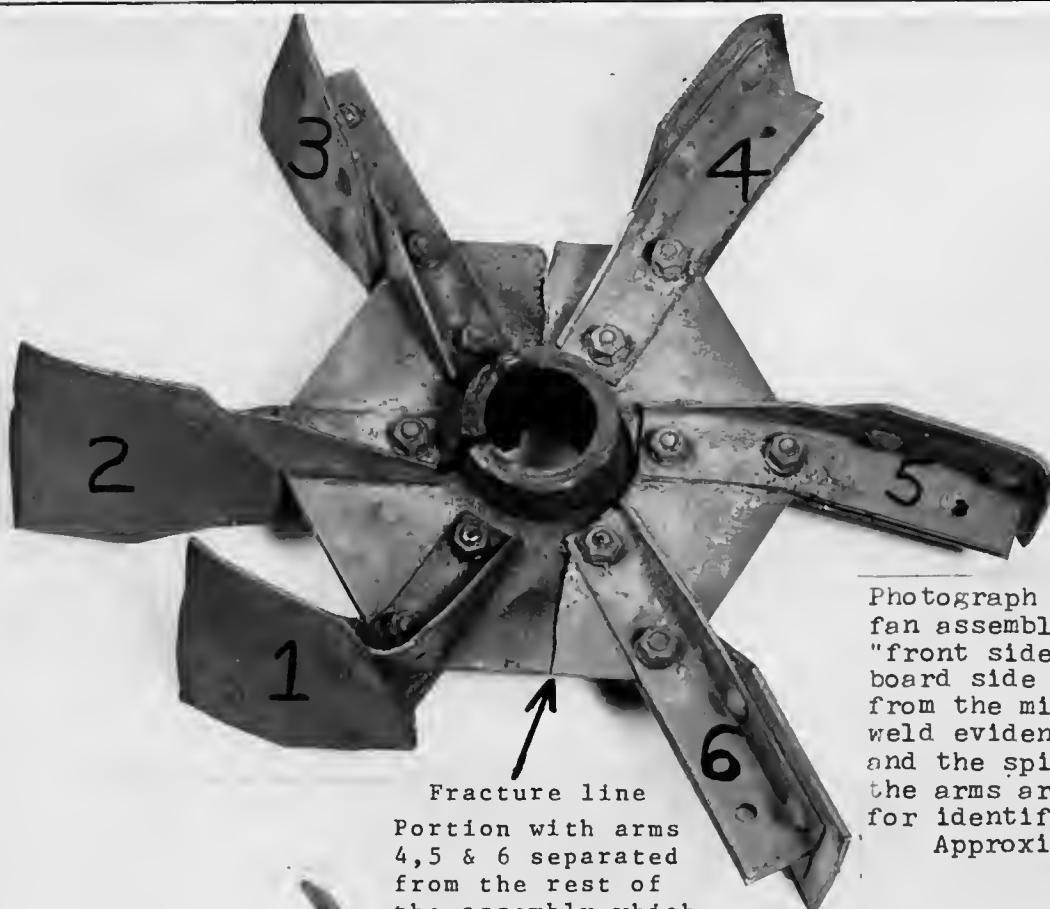
Fracture line
Portion with arms
4, 5 & 6 separated
from the rest of
the assembly which
includes the hub.

Photograph A1 - Failed blower fan assembly viewed from "front side", i.e., the out-board side or the side away from the mill. There is no weld evident between the hub and the spider. Numbers on the arms are arbitrary and for identification only. Approximately 1/3 X

4. A magnetic dye penetrant inspection was performed on the hub and attached segment of the spider. Clear evidence of a crack at the "line" of junction between the weld and spider plate (see right side of Photograph A2) was found. This crack extended completely around the periphery with the exception of one short distance. In addition, there is a crack in the weld bead near arm 1.

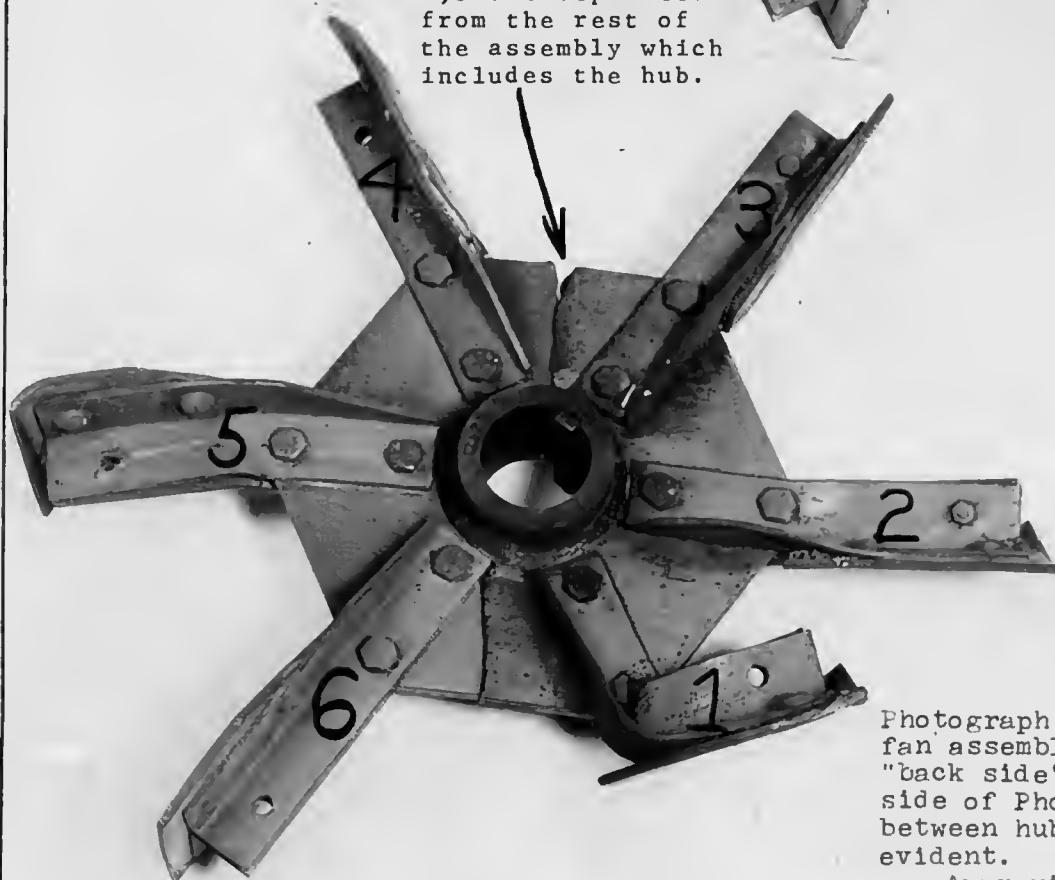
Photograph A2 - Failed blower fan assembly viewed from "back side", i.e., reverse side of Photo. A1. Weld between hub and spider is evident.

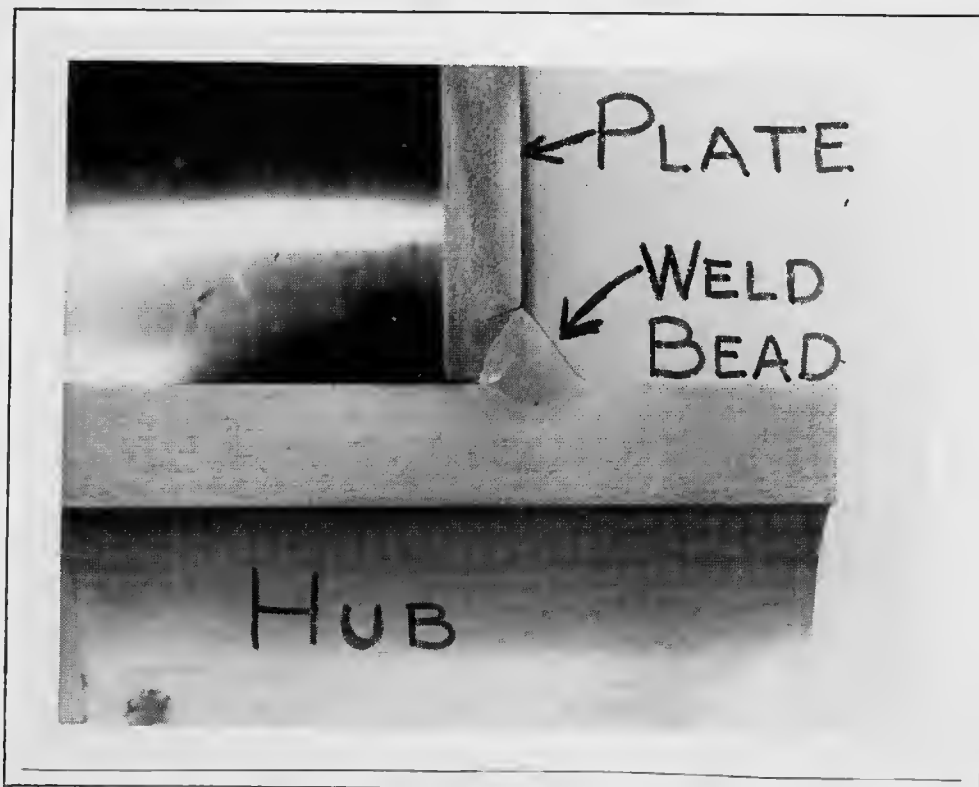
5. Radial cuts were made between arms 5 and 6 and at arm 2. A view of the cut close to arm 2 (See photograph A1 for location) is shown in Photograph B1. A crack is obvious at the point where the weld bead and the plate join (the crack discussed in item 4). A second crack is seen in the weld bead. This crack initiates at the end of the space or gap between spider plate and hub. A geometrical condition such as this creates a stress concentration which may cause the actual stress to be several times the nominal stress calculated by standard formulas. In the context of this specific blower fan assembly, this is a design (or manufacturing) defect which could have been avoided by welding on both sides of the joint rather than just

It is obvious that the first crack mentioned above starts at the junction of the weld bead and the spider plate. From Photograph B1 it appears that there is a more abrupt change in grain size along this junction than along the junction between the weld bead and the hub.

Photograph B1 -- Section of hub, weld bead, and spider from failed fan assembly. There are two obvious cracks: one starting at the edge of the weld and the other starting at the gap between hub and spider.

Even though Breeze Manufacturing argued that welding on only one side of the hub spider combination was not a design defect, it may be worth noting that shortly after settlement, the production process was modified to weld on both sides and thus eliminate the gap between hub and spider.

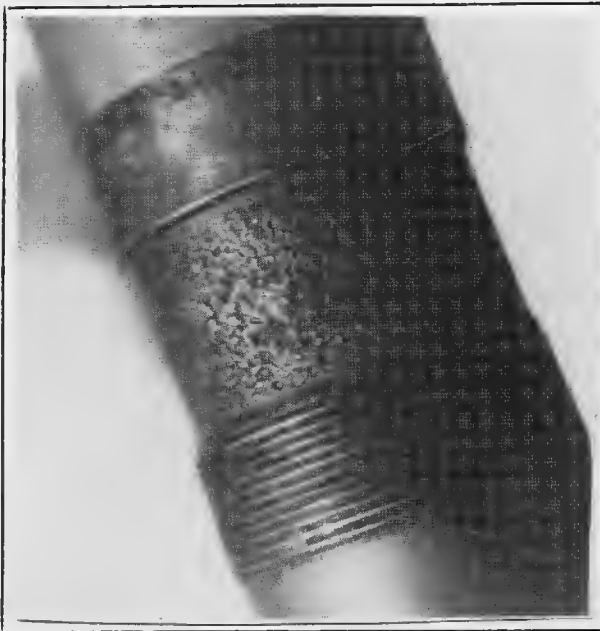
Photograph C1 -- Portion of cylinder shaft at the bearing at the drive end. Shaft produced by Lucky Equipment Sales and said to have been removed from Breeze mill in March 1970. Wear and pitting of the interface with the bearing is obvious. (Shaft A)
Approximately 3/4 X

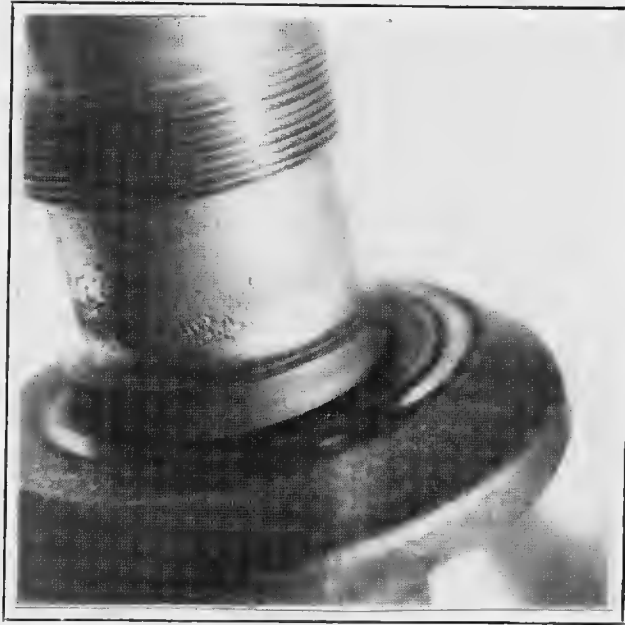
The inboard or drive end bearing showed wear on the inner race surface and evidence of over heating. The shaft surface upon which the bearing is seated showed extreme wear, and a clearance of 0.179 inches on the diameter between the inner race of the bearing and the shaft surface. With this much wear it is amazing that the machine would operate at all. The shaft was worn in other places and showed evidence of long service and maltreatment. The machine should not have been operated in this condition. The severe vibration and resultant stresses would be transmitted to the blower assembly and would cause a rapid fatigue failure.

Photograph C2 -- Portion of cylinder shaft at the bearing at the drive end. Shaft removed from Breeze mill on 4 June 1973. The shaft diameter is 45.44 mm (1.792 in). Wear and pitting of the interface with the bearing is obvious. (Shaft B)
Approximately 3/4 X

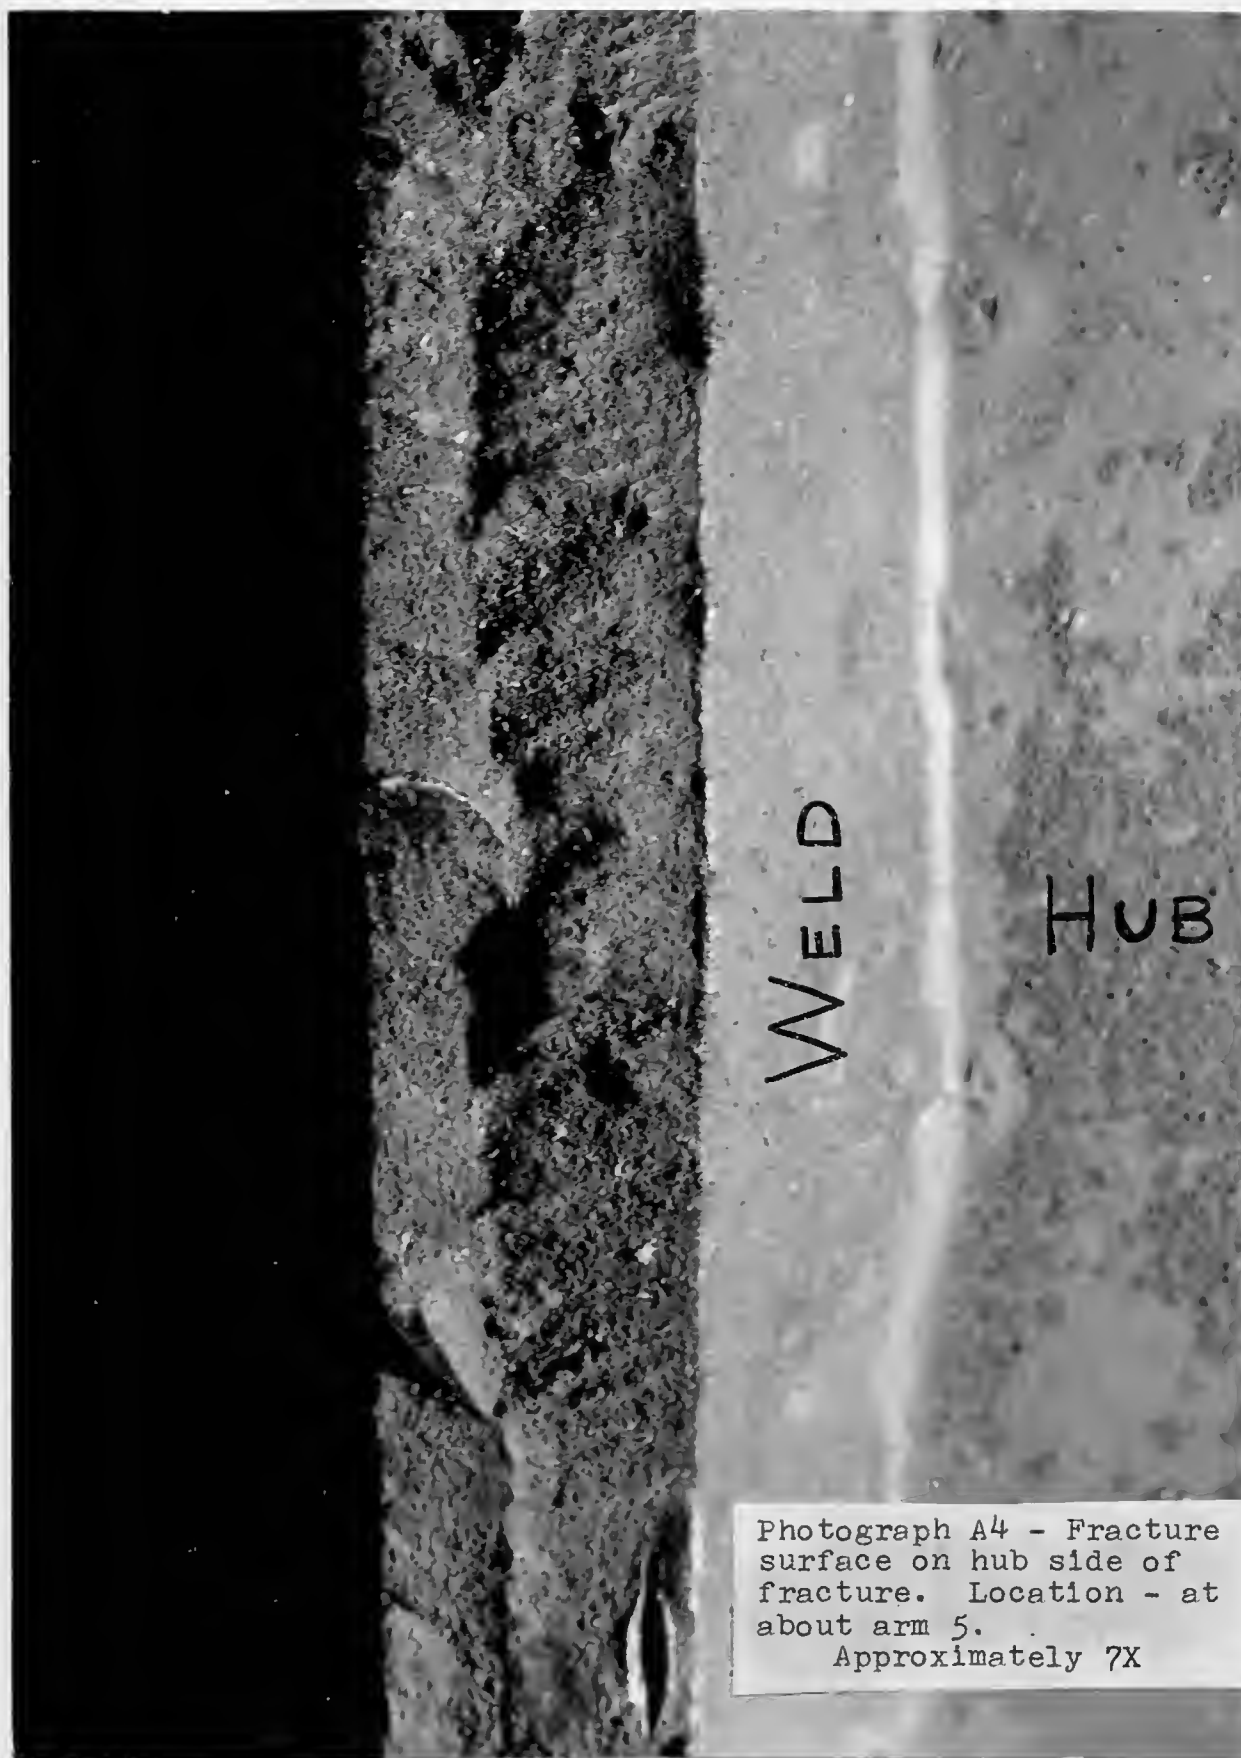
spider is shown in Photograph A3. This is between blower arms 5 and 6 (See Photos. A1 and A2). The "matching" fracture surface on the portion of the blower spider still attached to the hub is shown in Photograph A4.

Photograph A4 - Fracture
surface on hub side of
fracture. Location - at
about arm 5.
